**ASSESSMENT, REPAIR, UPGRADING OF  
HEADQUARTERS BUILDING  
STAGE 1: PROJECT INITIATION AND BRIEF:  
INSURANCE ASSESSMENT**

**35069.04 – STRUCTURAL – REP-001 Rev 1**

**STRUCTURAL CONDITION ASSESSMENT REPORT:  
FIRE DAMAGE TO MUNICIPAL HEADQUARTERS BUILDING**

**DECEMBER 2023**

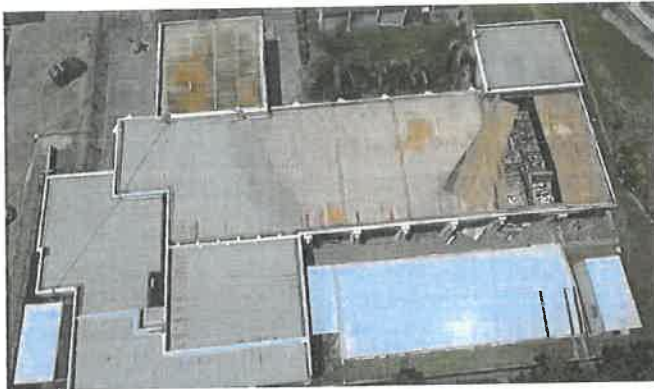
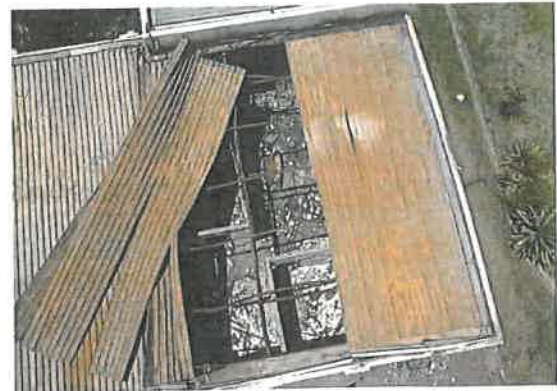
*Photo 2.1: Aerial view of Municipal Headquarters building, with roof structure with visible damage  
Photo 2.2 close up view from above at severely damaged area.*

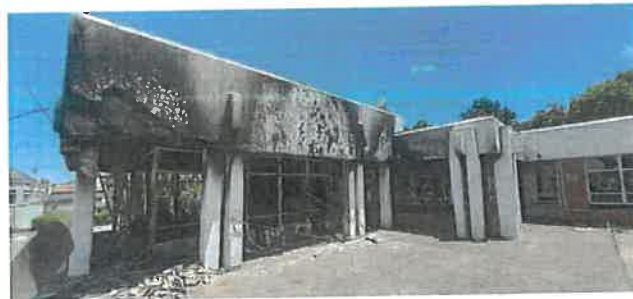
*Photo 2.3: Side elevation of building with fire damage visible on the concrete frame.*

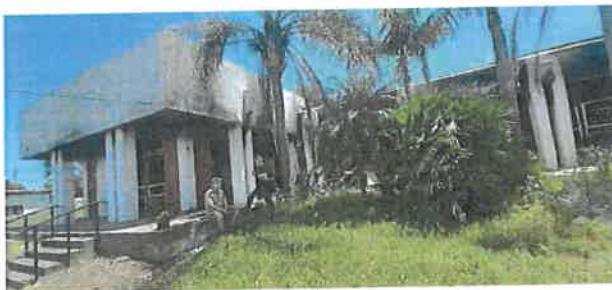
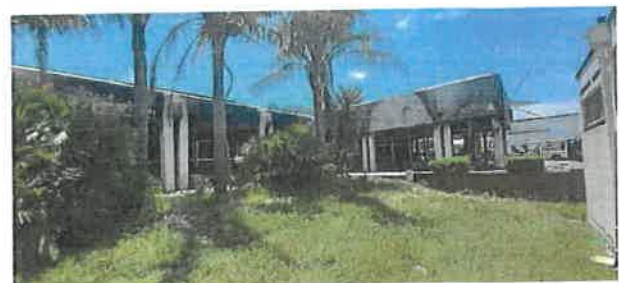
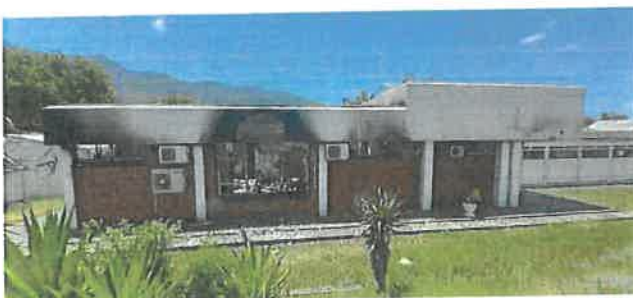
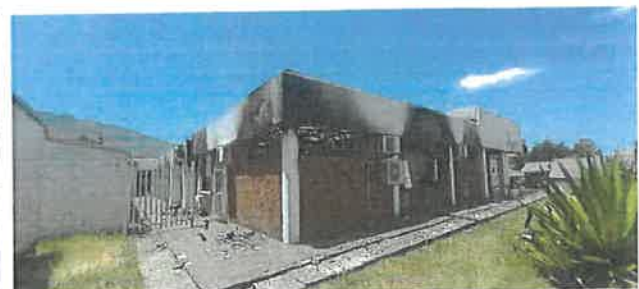
*Photo 2.4-2.7: Various elevations of the building with fire damage on the external concrete frame.*

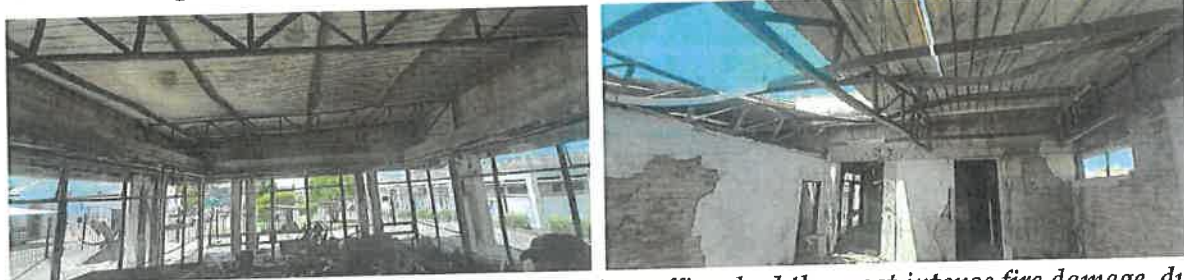
*Photo 3.1 & 3.2: Geodebt offices and Financial services offices had the most intense fire damage, due to many documents stored in the building that fuelled the fire. Large open windows allowed some of the heat to escape out of the building and that is why the roof structure did not collapse, even though the fire was very intense.*

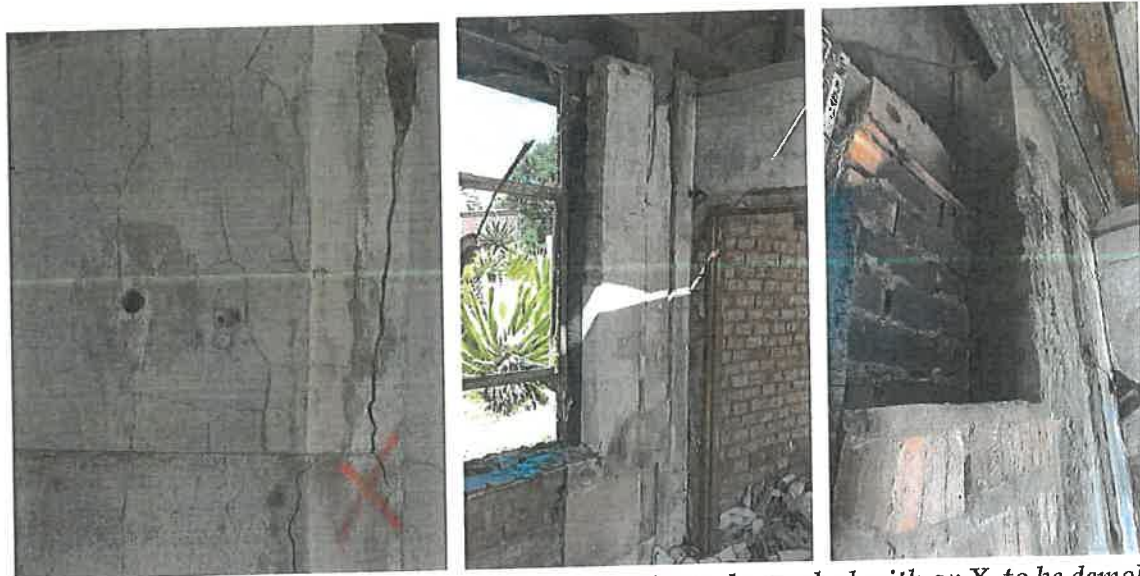
*Photo 3.3: Example of typical brick wall with large visible cracks marked with an X, to be demolished.  
Photo 3.4 & 3.5: Brick wall nibs around timber window frames have lots of heat damage in the cavities that are not so obvious, from a visual assessment only.*

Walls with large cracks were marked with an X , on site, that was deemed that needed to be demolished. The intersecting brick walls provide lateral restraint to each other. Removing some of the walls, will make some of the adjoining walls unstable.

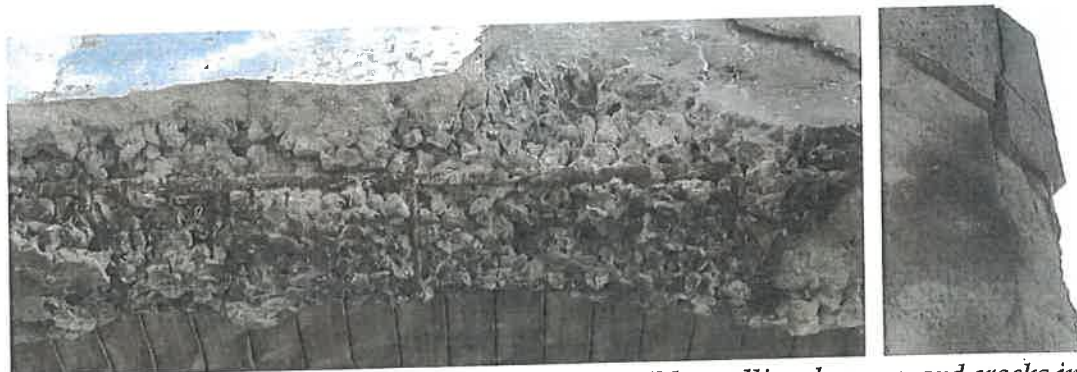
*Photo 3.6 & 3.7: Concrete beam on façade with localized visible spalling damage, and cracks in concrete façade beam. Note the visible corrosion that is related to the heat damage that will also start forming at the rest of the rebar in the heat-damaged concrete, where oxygen can reach the rebar.*

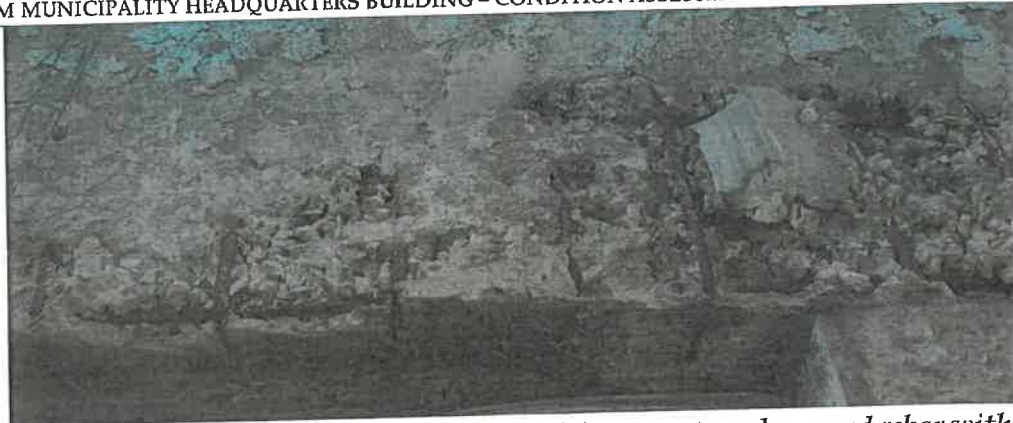
*Photo 3.8: Internal concrete beam, with spalling of the concrete and exposed rebar with visible corrosion. The concrete cover on these concrete beams seems to have deteriorated, due to the heat of the fire damage.*

See diagram below annotated with a rating of the various rooms. Concrete spalling with corroding rebar visible was noted. Removal of all the plaster will have to be done, to confirm any other areas where similar spalling has occurred, but not yet visible.

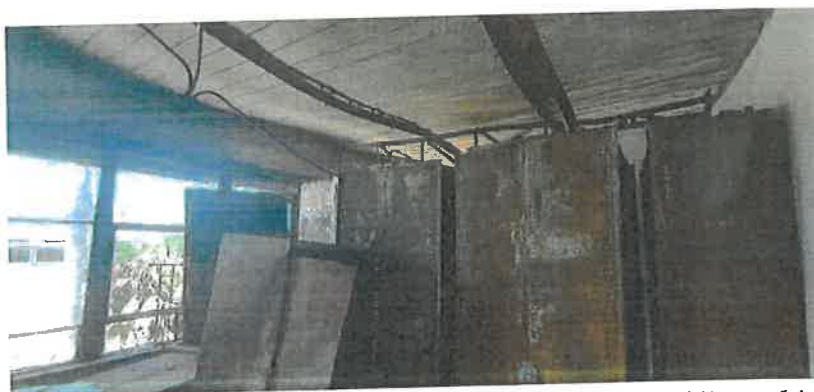
*Photo 3.9 & 3.10: Central passage with extensive fire damage visible. Note the filing cabinets in the offices that had lots of documents, that fuelled the fire to be more intense in those areas.*

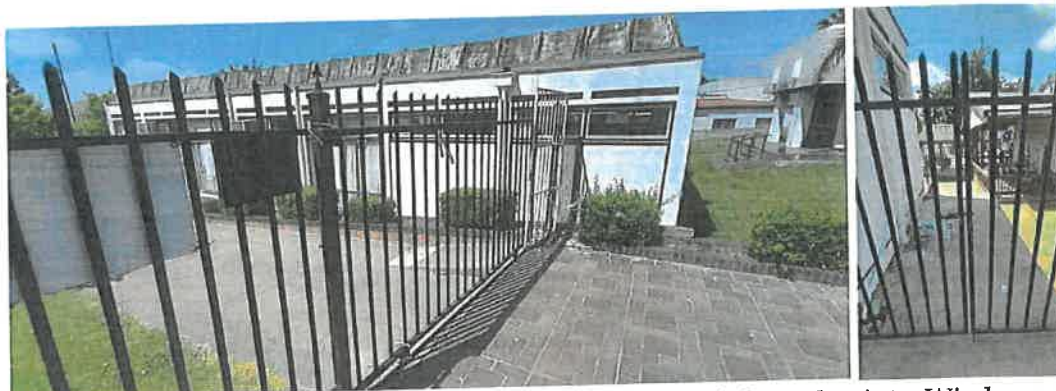
*Photo 3.11 & 3.12: Sliding gates on the perimeter fence is damaged, from the riots. Windows were also damaged on the adjacent buildings, during the riots.*

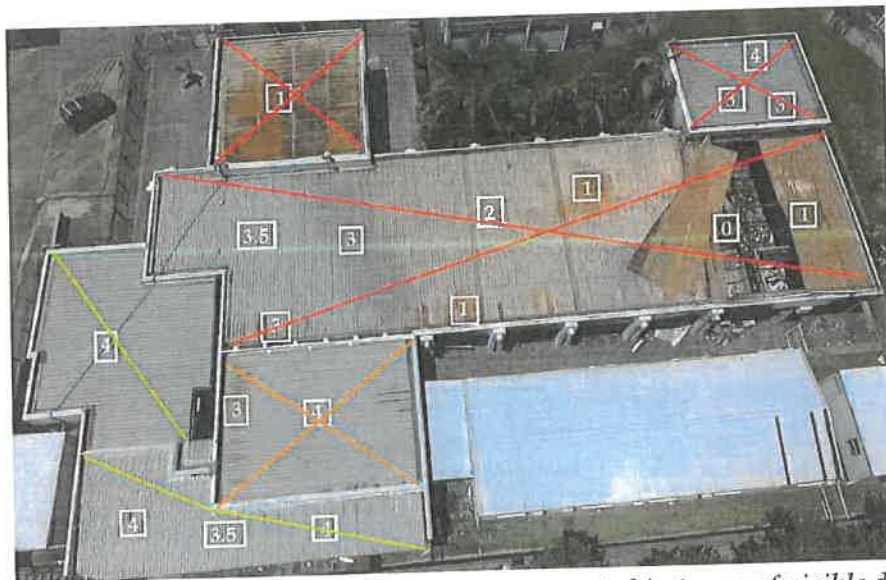
Figure 4.1 View of the roof with visible fire damage. Areas are rated in terms of visible damage. Red is roofs that are deemed that will need to be replaced, and orange marking is deemed will need remedial treatment.

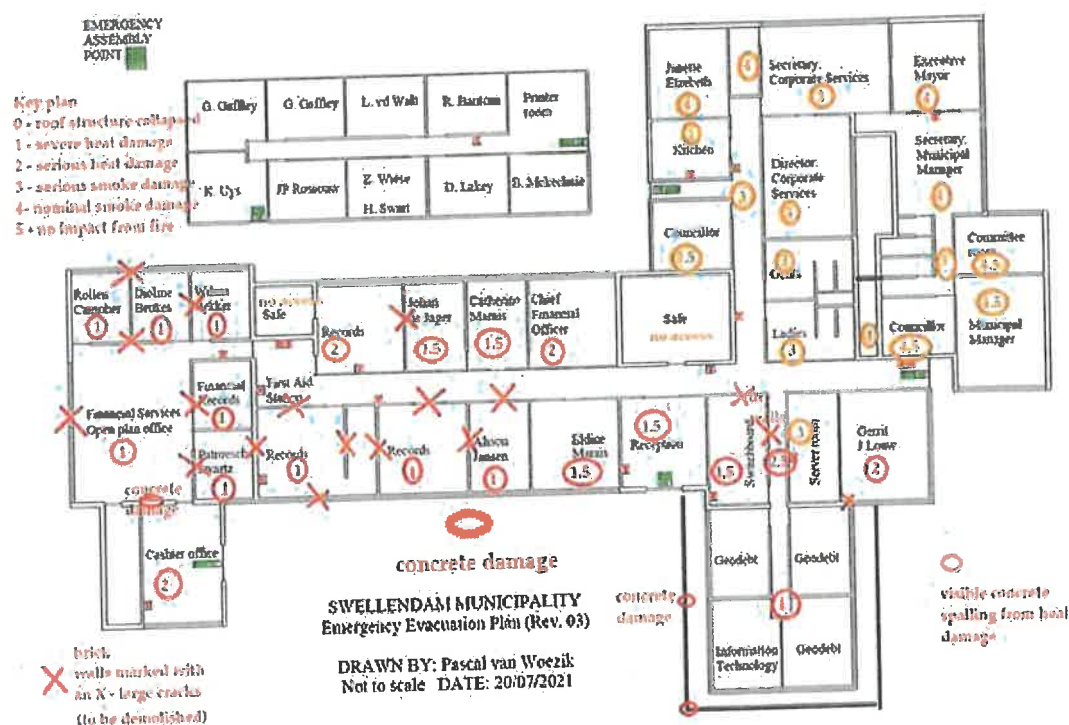
The internal building plan was marked up with the different rooms rated on a scale from 0 to 5, and building walls with visible large cracks were marked with an X. Some visible spalling on the concrete was also observed.

*Figure 4.2 Emergency evacuation plan of building, with notes related to the internal fire damaged, noted on site.*

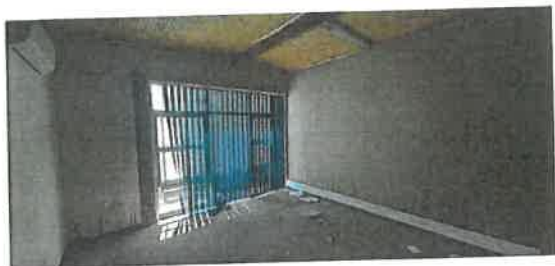
*Executive major office rated 4*

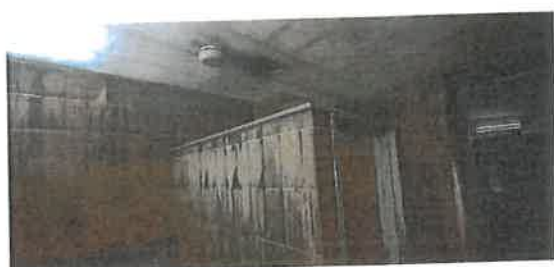
*Gents bathrooms rated 3*

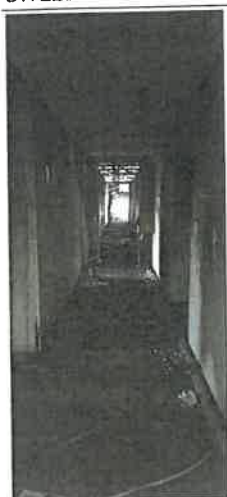
*Hall 2 rated 3*

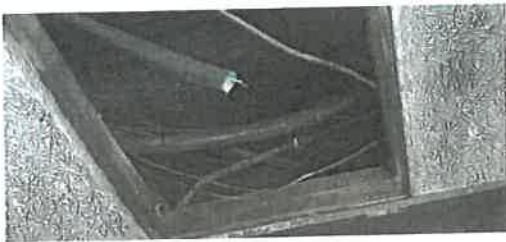
*Ceiling void hall 2 smoke damage*

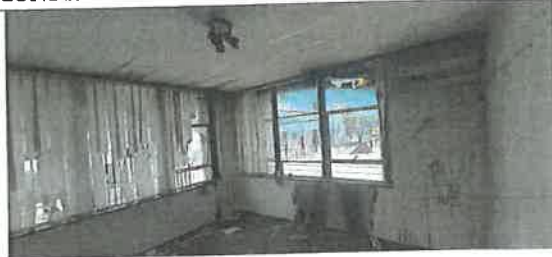
*Gerrit Louw's office rated 2*

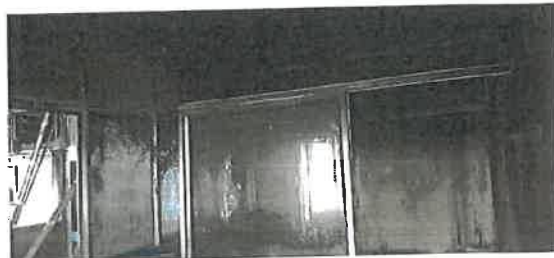
*Switchboard room 1.5*

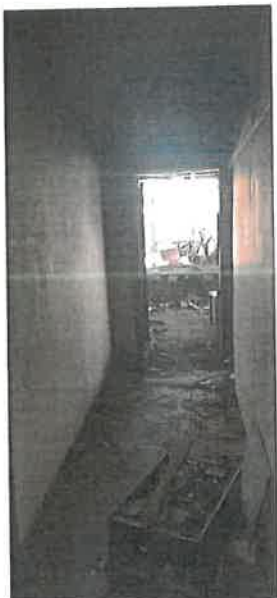
*Hall 5 rated 2.5*

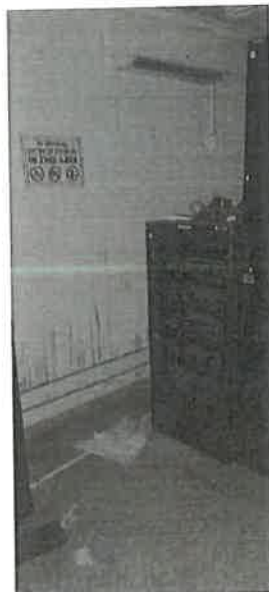
*Server room rated 3*

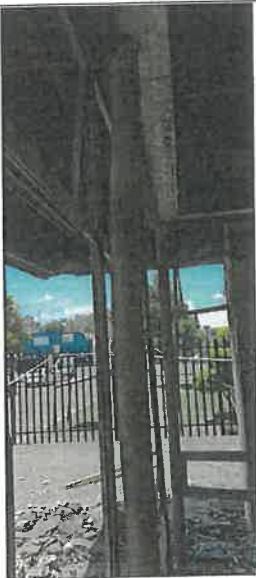
*Steel post bent due to fire damage*

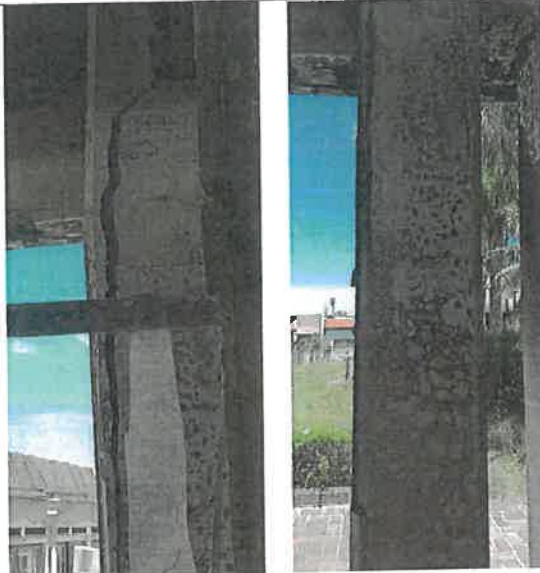
*Column with plaster spalling and plaster removed*

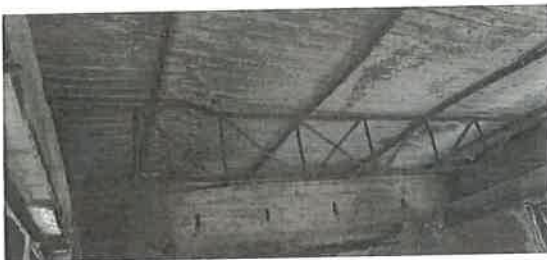
*Steel truss with localized buckling of some members*

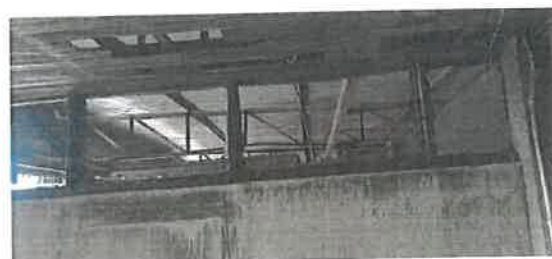
*Roof structure visible due to damaged ceilings*

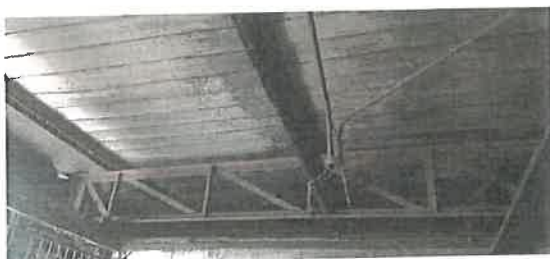
*CFO room rated 2*

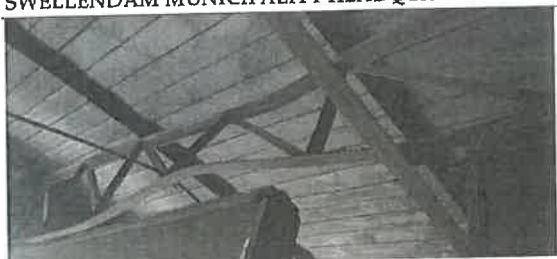
*Bent truss from heat of fire*

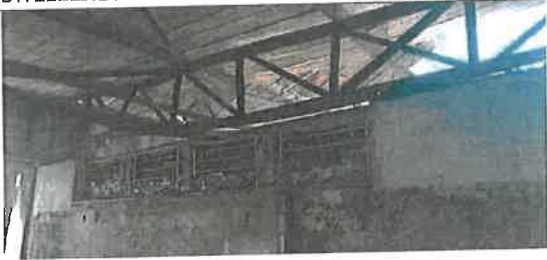
*Records room rated 1*

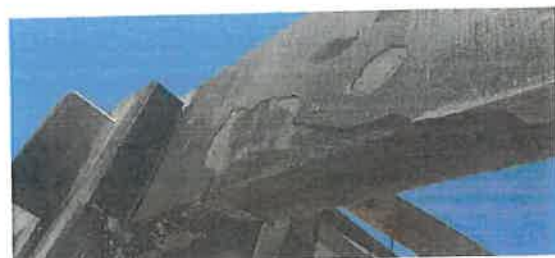
*Concrete frame with spalling plaster*

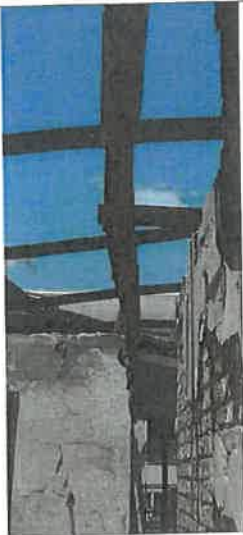
*Truss bowing due to fire damage*

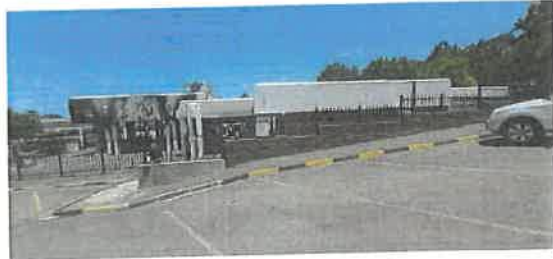
*Side elevation of building with only smoke damage*

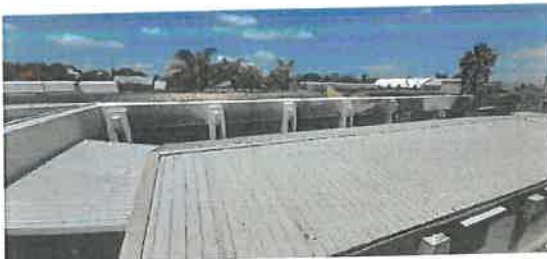
*Back view with smoke damage visible*

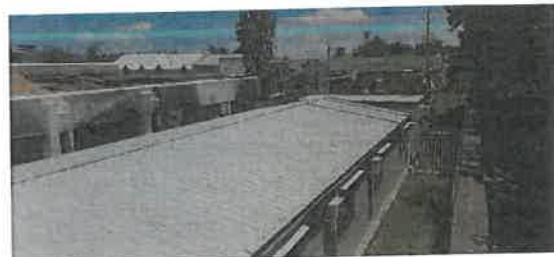
*Back building roof and damaged roof visible*

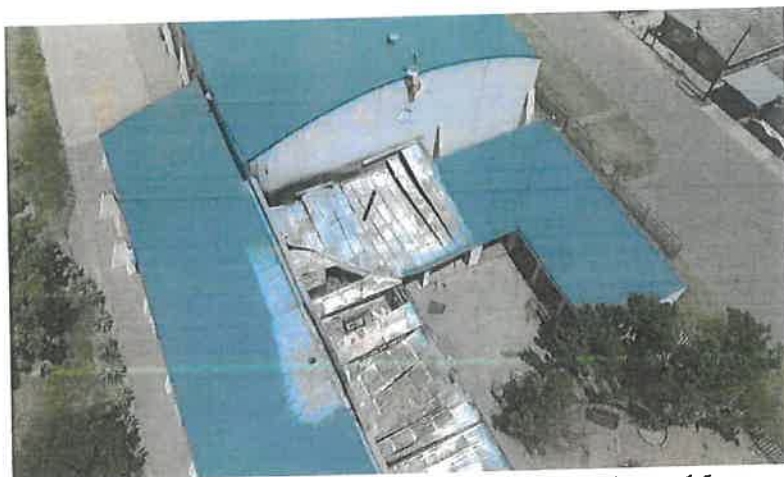
*Photo 2.1 Thusong community centre with visible roof damage*

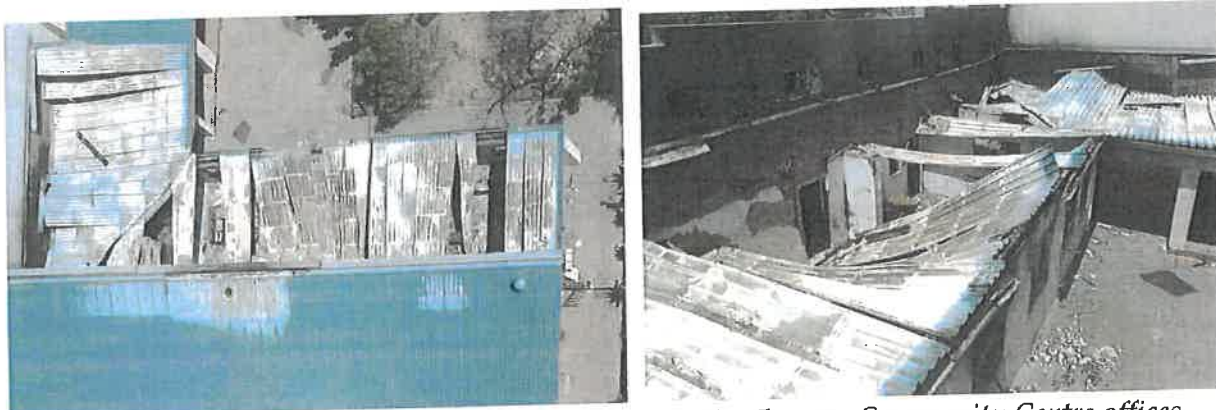
*Photo 2.2& 2.3: Close up view of the fire damage to the Thusong Community Centre offices*

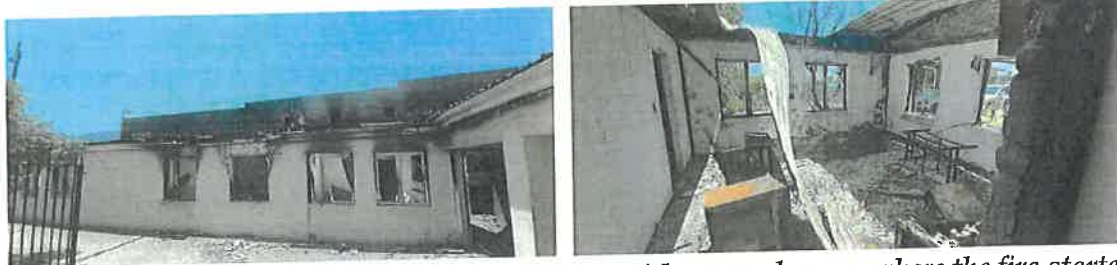
*Photo 3.1 & 3.2 Thusong community centre offices with severe damage where the fire started.*

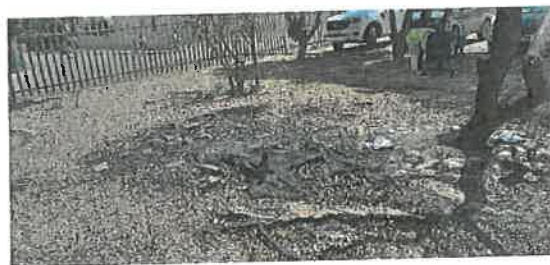
*Photo 3.3 Ashes from a plastic bench that was burnt down, and damage to the perimeter fence in the background. A fire fighting vehicle was apparently also set alight by the protestors.*

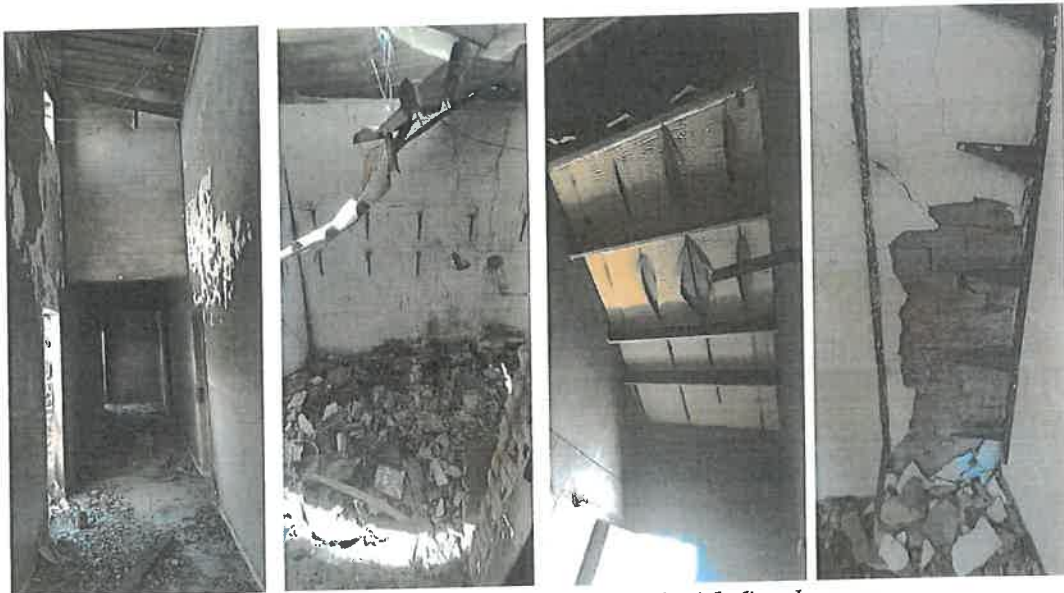
*Photo 3.4 Passageway with high roof with fire damage.*

*Photo 3.5 Document storage area with intense heat damage.*

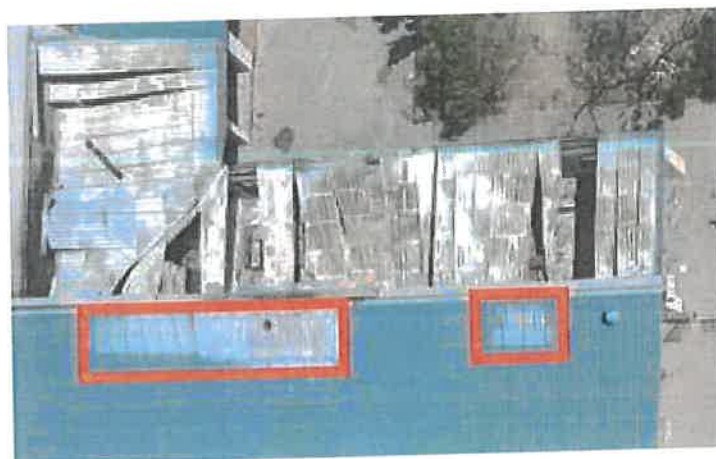
The fire also spread to a section of the passage, as indicated in the figure below. The roof structure on that side of the building, also has extensive smoke damage.

*Figure 4.1 Visible roof sheeting damage above high level passage area, that is marked in red blocks*

Re-sheeting only a portion of that roof was considered. A simple patch repair will be to replace the +/-20% of the roof sheets with fire damage. Such a patch repair, will probably have waterproofing issues in future, and storm damage in future would be highly likely. A more extensive repair would require replacing 60% of the roof sheets in that area. The other 40% of the roof sheets will require cleaning and treating against future heat induced corrosion. To clean and treat that roof structure effectively, the entire roof covering will have to be removed, for proper cleaning and treating and reinstalled. This is double handling that will probably also damage some of the sheets. The simplest and best long term solution would be to replace all the sheets on that area of the roof, for a weather proof and durable storm resistant roof, that also has a material guarantee.

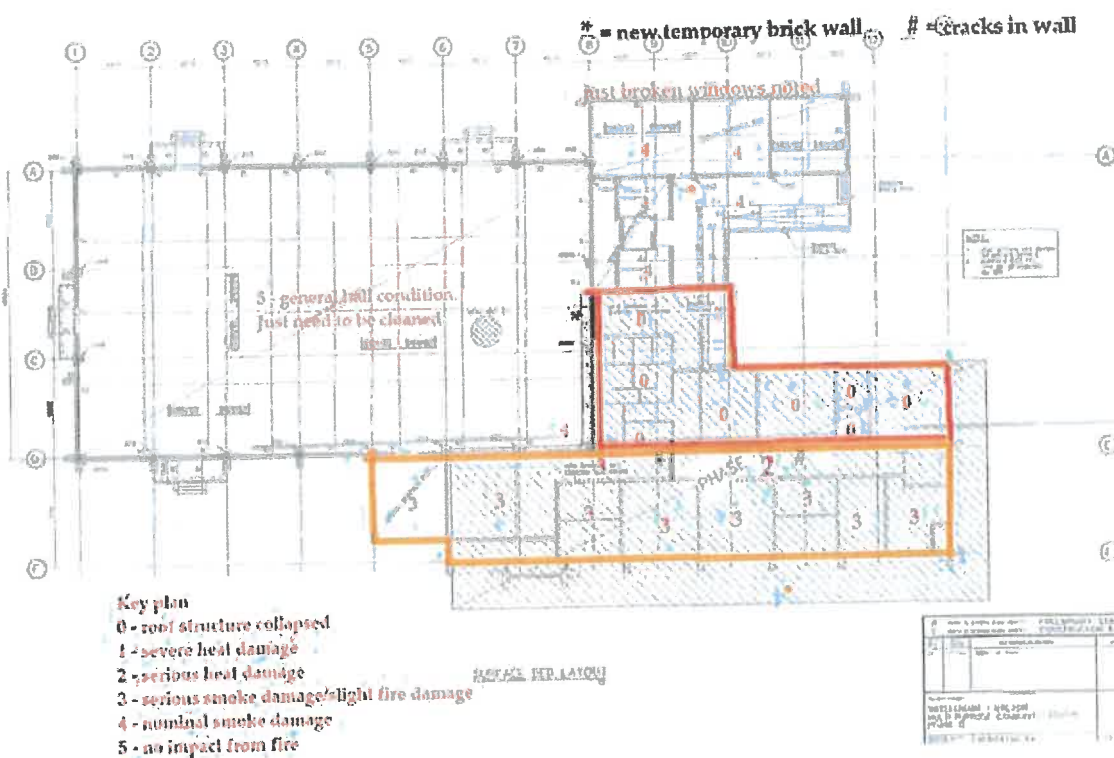
Figure 4.2 Architects drawing with brickwork in the areas indicated in red (including the passage wall on the fire side), to be demolished and re-built. The floors in the area in red will also probably have to be rebuilt. (to be confirmed on site)

Diagram below indicates the areas where the walls will have to be rebuilt (red block). The area in the orange block, the internal brickwork to be cleaned and finishes reinstated, as per the info in Annexure D.

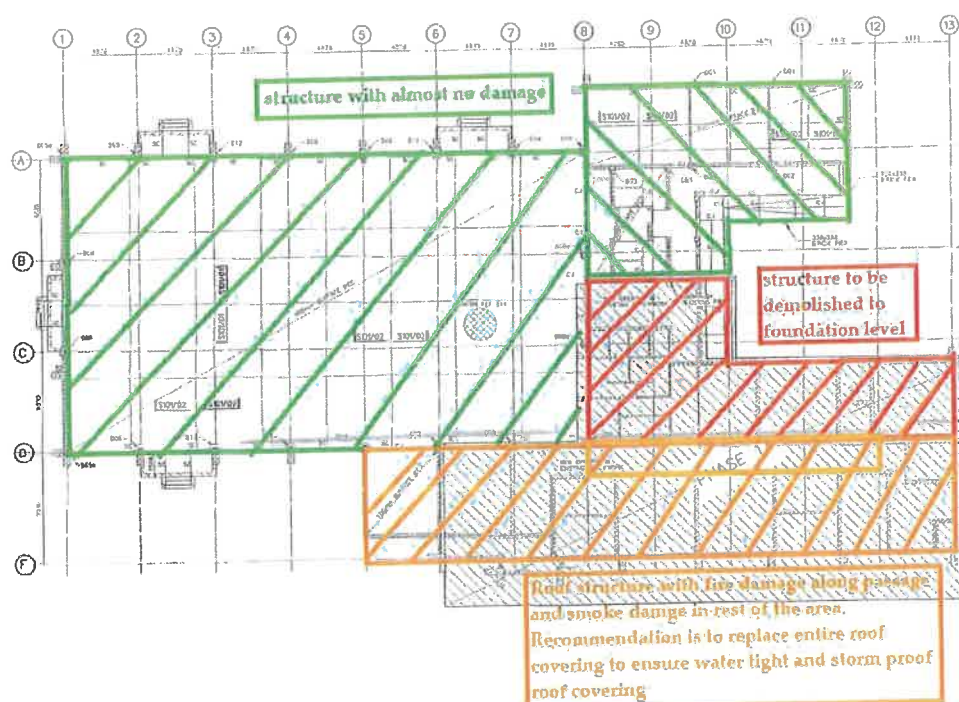
Figure 5.1 Architects drawing with roof structure in red and orange areas to be replaced.

Below is a diagram indicating in principle the roof structure to be removed (red and orange hatch) and brickwork to be demolished (red hatch only), to foundation level. The wall on the passage side where the fire started, also to be removed and rebuilt. The floors at the hot-spot areas of the fire, also probably cracked due to the heat, and will need to be demolished and removed.

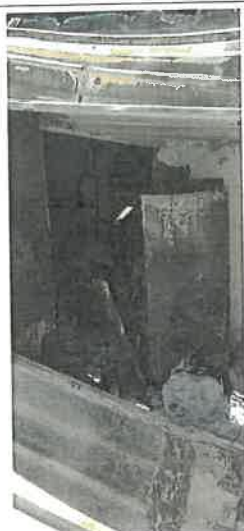
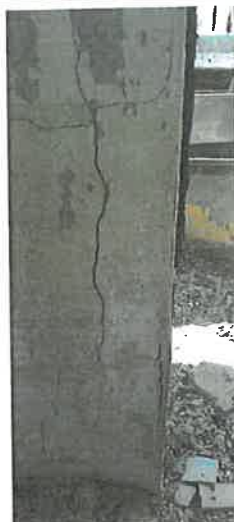
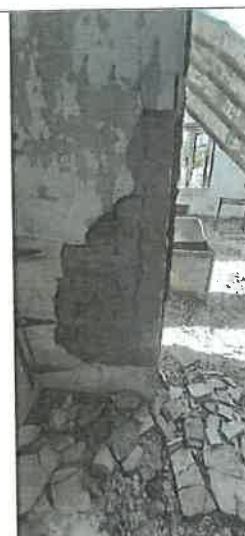
*Brick walls with large cracks from fire damage*

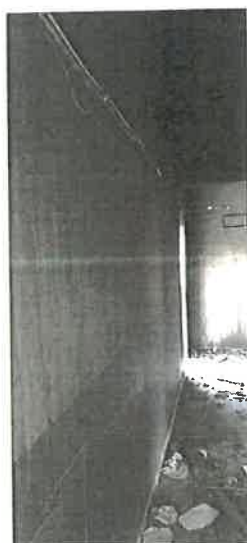
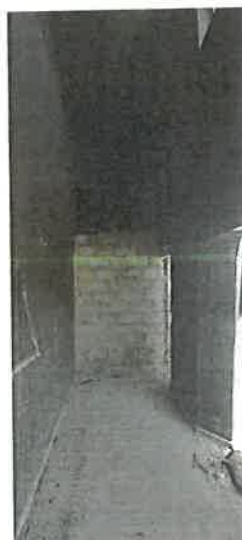
*Passageway with wall where fire started on other side, and the brick wall built to enclose the hallway for security purposes.*

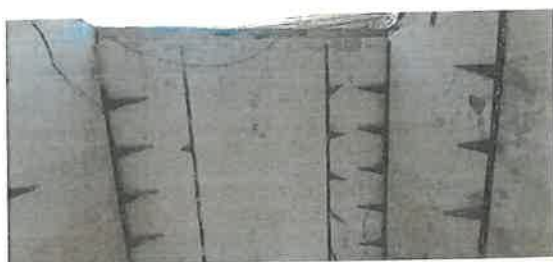
*Records room where the walls are severely cracked*

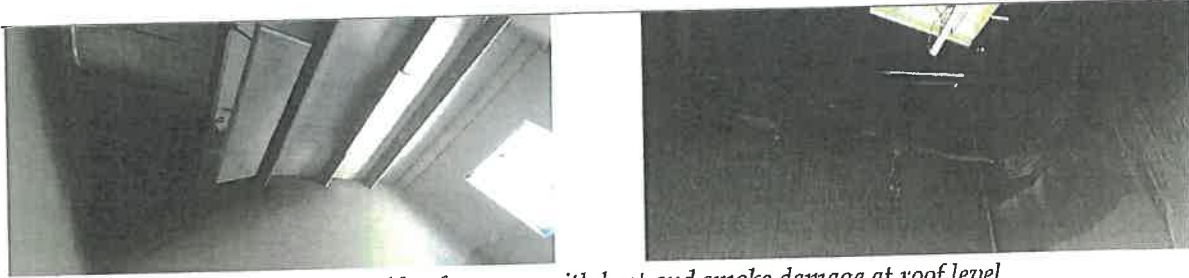
*Rooms on other side of passage with heat and smoke damage at roof level*

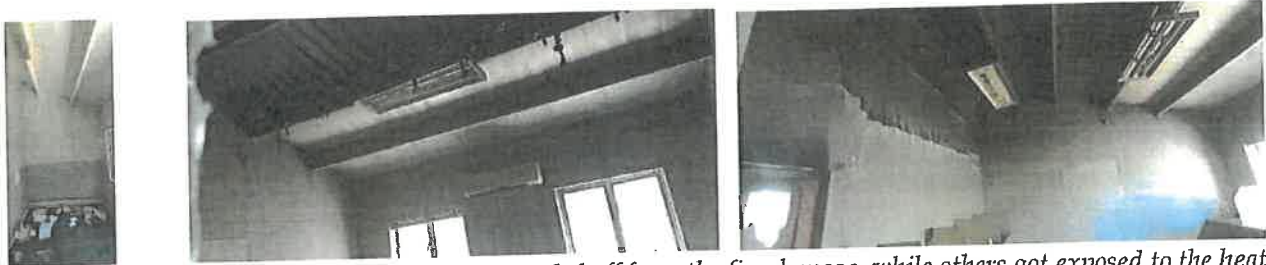
*Extent of damage varies, as some rooms were sealed off from the fire damage, while others got exposed to the heat and smoke*

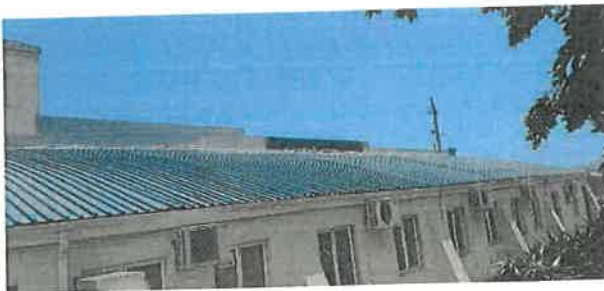
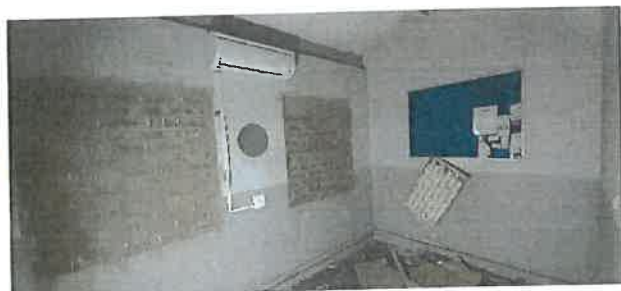
*Roof structure with fire damage in the passage area and heat damage in some of the adjacent rooms. Note the windows that have been bricked up, for security purposes for the main hall.*

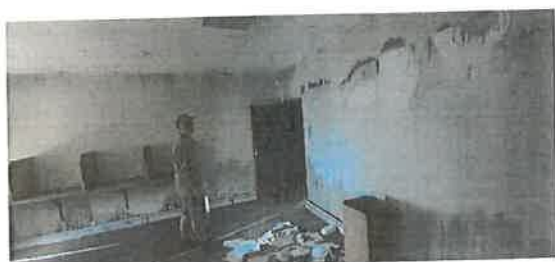
*Room with smoke damage*

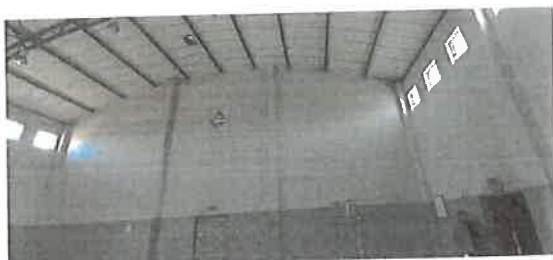
*View of hall eaves with slight smoke damage in top right corner.*
