**ASSESSMENT, REPAIR, UPGRADING OF  
HEADQUARTERS BUILDING  
STAGE 1: PROJECT INITIATION AND BRIEF:  
INSURANCE ASSESSMENT**

**35069.04 – STRUCTURAL – REP-001 Rev 1**

**STRUCTURAL CONDITION ASSESSMENT REPORT:  
FIRE DAMAGE TO MUNICIPAL HEADQUARTERS BUILDING**

**DECEMBER 2023**

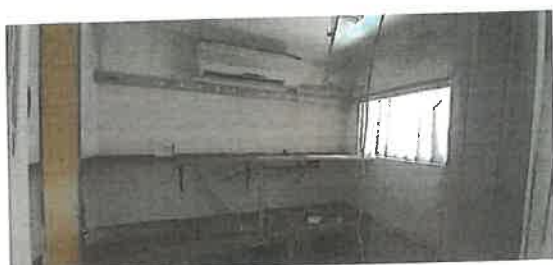
*Old server room rated 4*

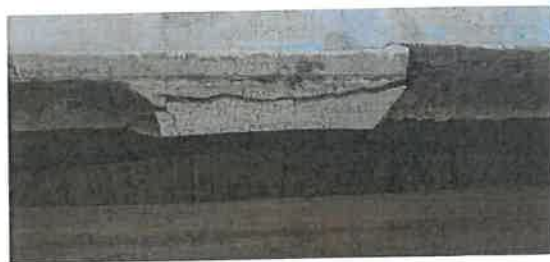
*Plaster hanging on concrete beam - H&S risk*

Safe removal of the damaged roof structures is a high-risk operation. The overhead concrete beams also have plaster that could injure people, when it falls off, during the site clearing.

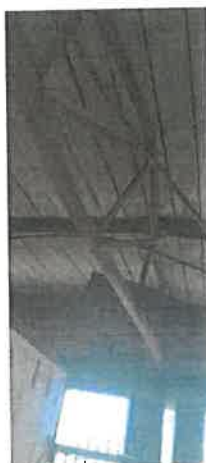
*Records room with bent steelwork rated 1*

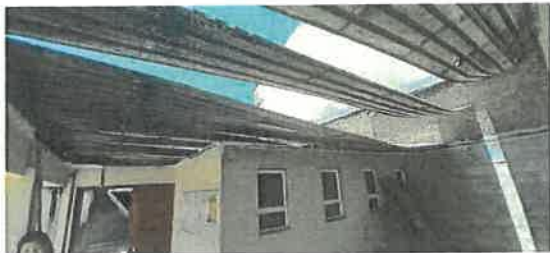
*Roof sheets with nails through is a safety risk*

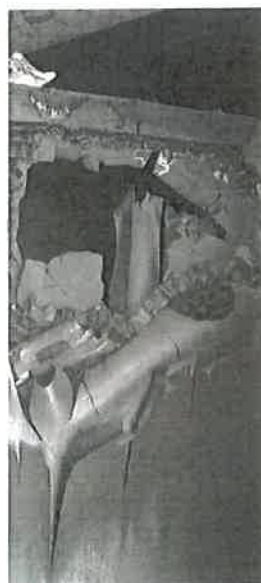
*Timber door at toilets*
