**ASSESSMENT, REPAIR, UPGRADING OF  
HEADQUARTERS BUILDING  
STAGE 1: PROJECT INITIATION AND BRIEF:  
INSURANCE ASSESSMENT**

**35069.04 – STRUCTURAL – REP-001 Rev 1**

**STRUCTURAL CONDITION ASSESSMENT REPORT:  
FIRE DAMAGE TO MUNICIPAL HEADQUARTERS BUILDING**

**DECEMBER 2023**

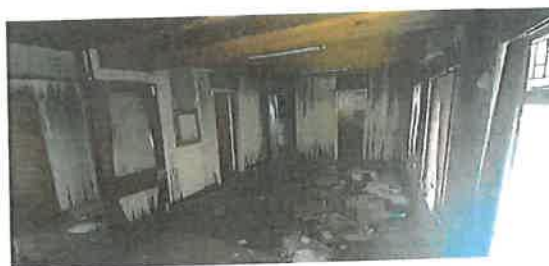
*Secretary corporate services office rated 3*

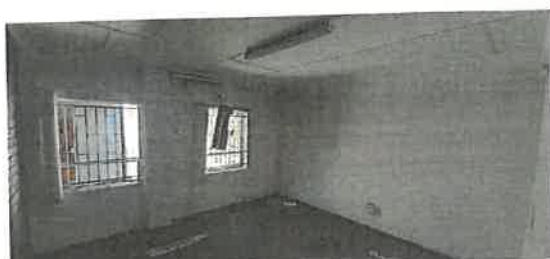
*Liesel's office rated 4*

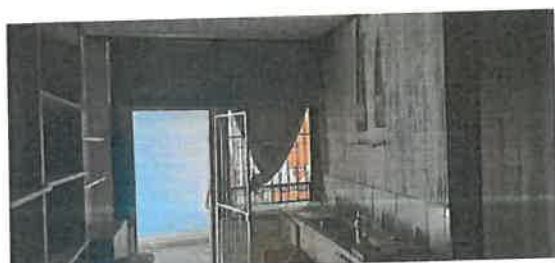
*Kitchen rated 3*

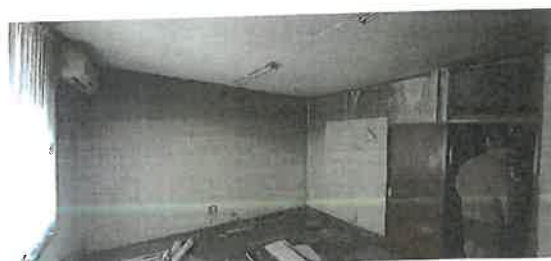
*Director Corporate services office rated 3*

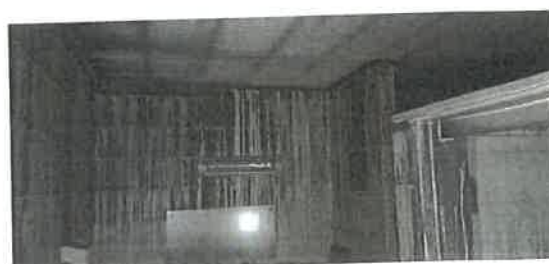
*Ladies bathroom rated 3*

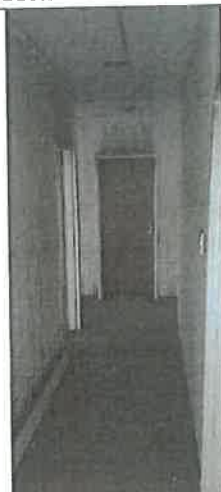
*Hall 3 rated 4*

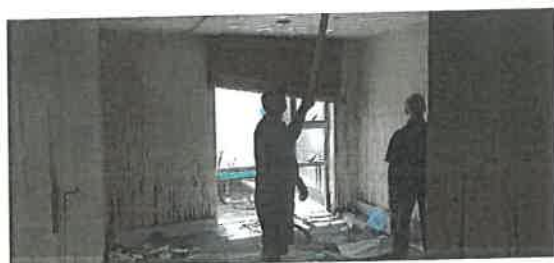
*Secretary municipal manager office rated 4*

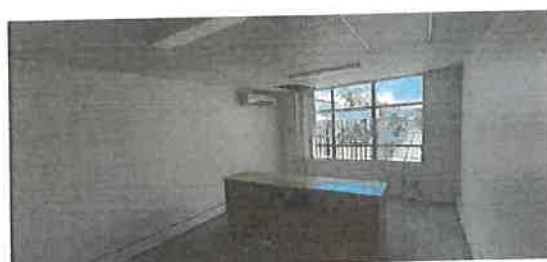
*Municipal manager office rated 4.5*

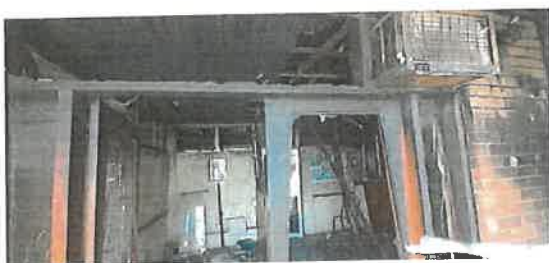
*Reception room rated 1.5*

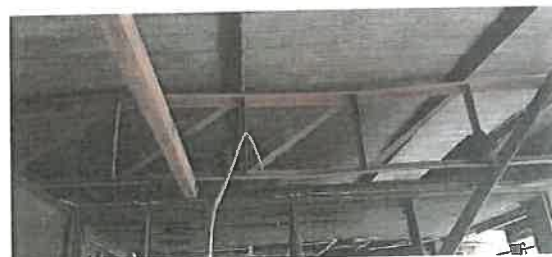
*Eldine Marais office rated 1.5*

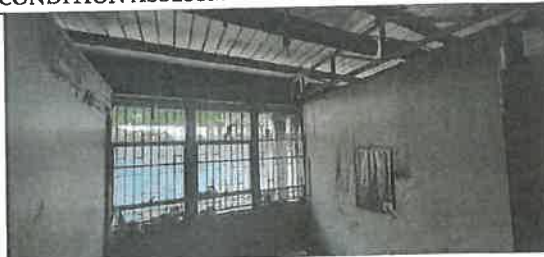
*Catherine Marais office rated 1.5 steelwork*

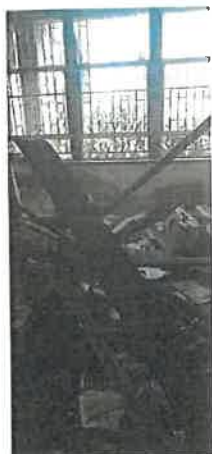
*Alison Jansen's office rated 1*

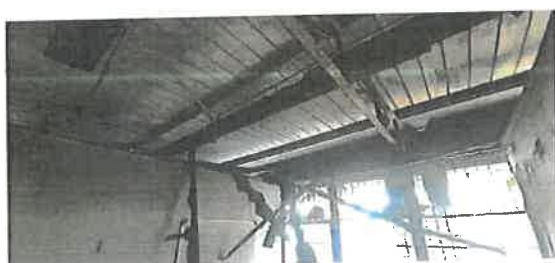
*Johan de Jager office rated 1.5*

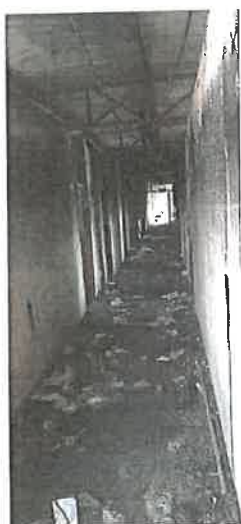
*Hall 2 rated 1*

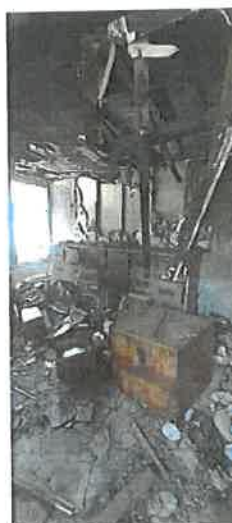
*Records room rated 2*

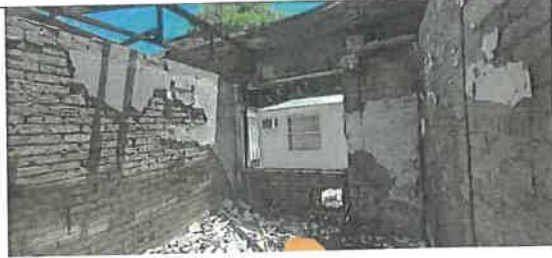
*Wilma Bekker's office rated 1*

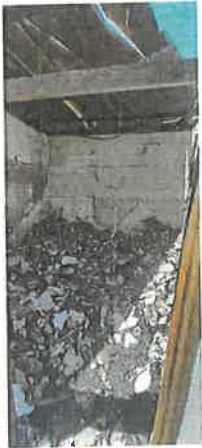
*Financial records room rated 1*

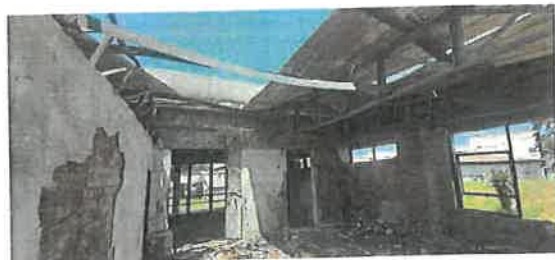
*Financial services room rated 1*

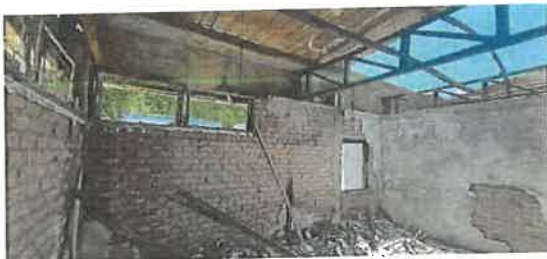
*Rolien Campher & Dioline Beukes' offices  
rated 1*

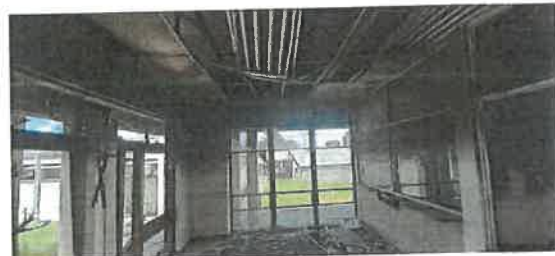
*Cashier offices rated 2*

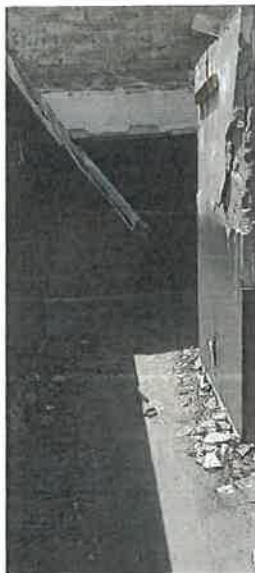
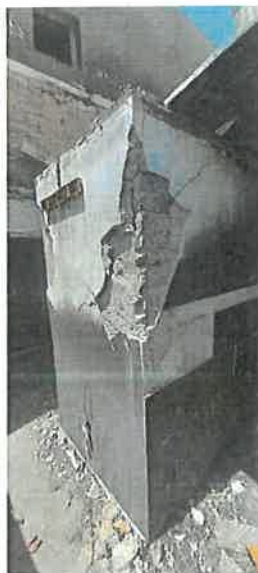
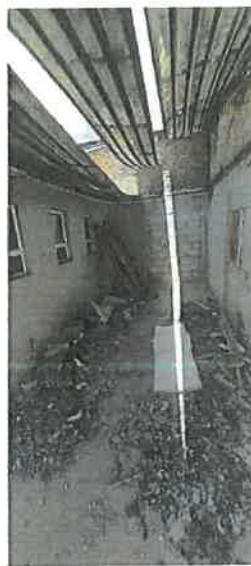
*Phase 1 hallway rated 2 roof purlins gone Entrance door was bricked up after the fire*

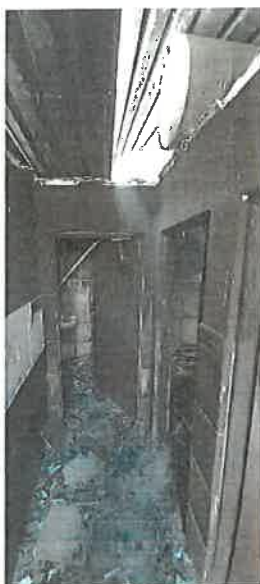
*Phase 1 entrance to staff toilets*

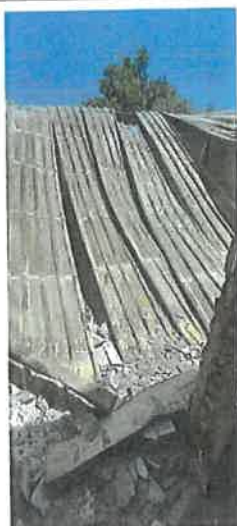
*Roof structure destroyed at offices at origin of fire, with records room.*

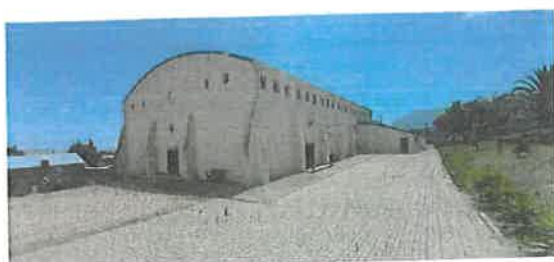
*External view of community centre*
